## Monthly Environmental Report

For Month Ending 31 May 2018

# ENDEAVOR MINE

Name of Operation	Endeavor Mine
Name of Licensee	Endeavor Operations Pty Ltd
Environmental Protection Licence	No: 1301
Reporting Period Start Date	1 May 2018
Reporting End Date	31 May 2018
Version	1
Author	Dr Keith Halford
Approver	Phil Gilligan

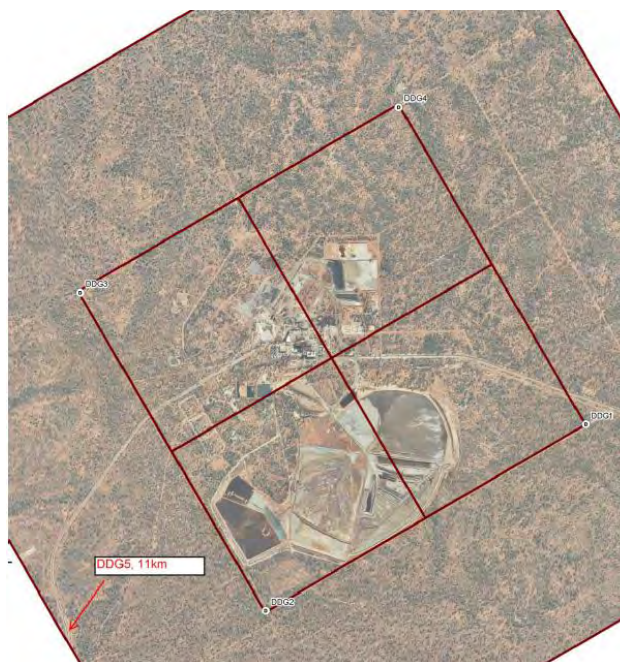
Figure 1: Endeavor Mine Dust Monitoring Locations

As show in the aerial photo (Figure 1), there are 5 dust monitoring locations on the boundary of the lease, with one located 11kms from the site at the turnoff to the Mine site near the Louth Road. This station was positioned to establish background levels.

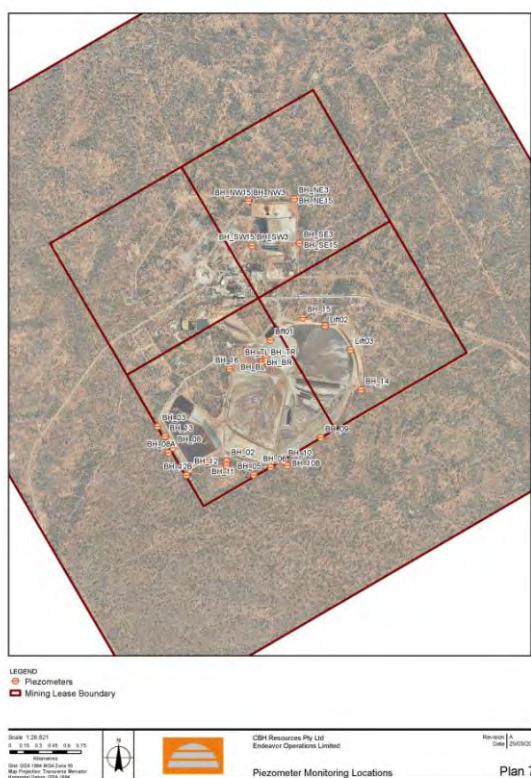
Figure 2: Location of the Piezometer Monitoring Locations

Endeavor Mine's groundwater monitoring locations are concentrated around the perimeter of the Central Tailings Discharge (CTD) and the Sector 5 Tailings Storage Facility (CTF), while surface water monitoring locations are focused on water storages that could potentially discharge to environment during a major rain or storm event. Table 5 describes the monitoring stations where Figure 2 shows the locations of the piezometers. Depending on availability of water or flow, unfortunately on some occasions, piezometers cannot be monitored as a result of being dry.

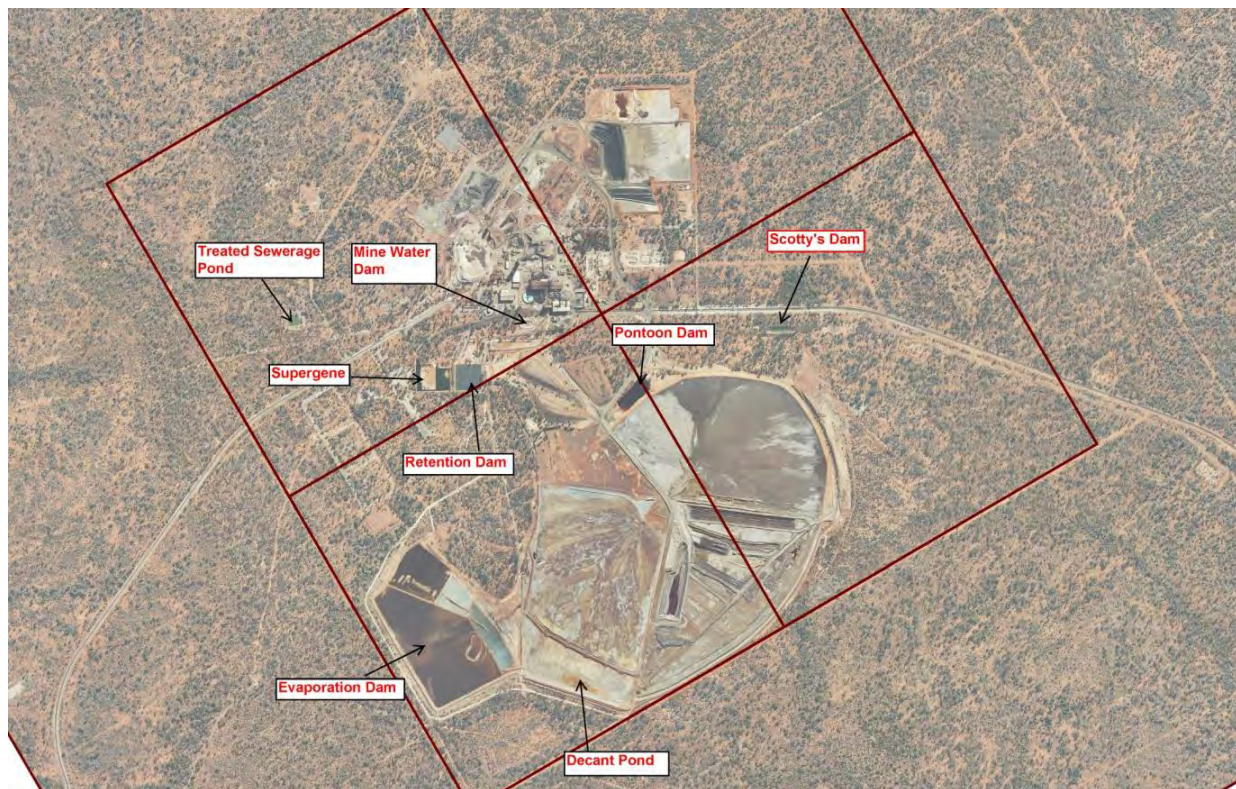
Figure 3: The Endeavor Mine: Main Water Storages

Figure 3 shows the location of the surface water dams on site that are monitored for water quality bi-annually.

No surface sampling was undertaken during May 2018. Water sampling will be undertaken as part of the Bi-Annual monitoring in June 2108. Weekly measurement of pH has been undertaken at the Evaporation Pond and the results remained consistent and stable. Due to the current dry conditions and distinct lack of rainfall, it was decided to hold the next round of surface sampling as part of the Bi-Annual monitoring in June.

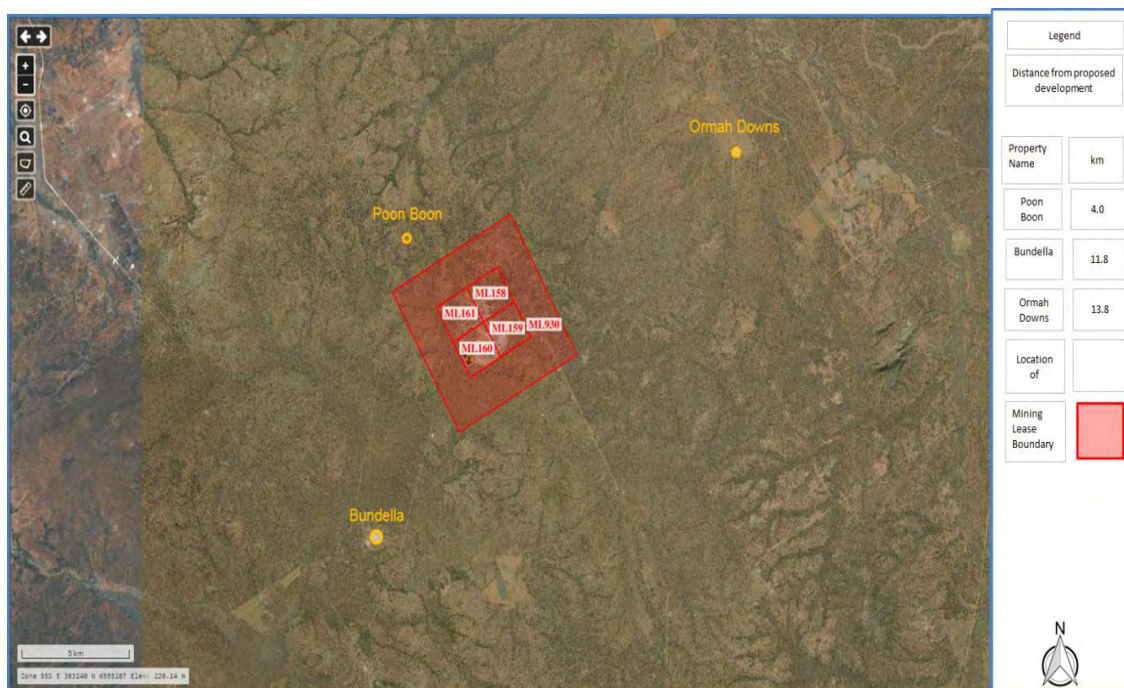
Figure 4: Closest Neighbours to Endeavor Mine

Potential Monitoring locations will include neighbouring properties. Figure 4 shows the location of the neighbouring properties.

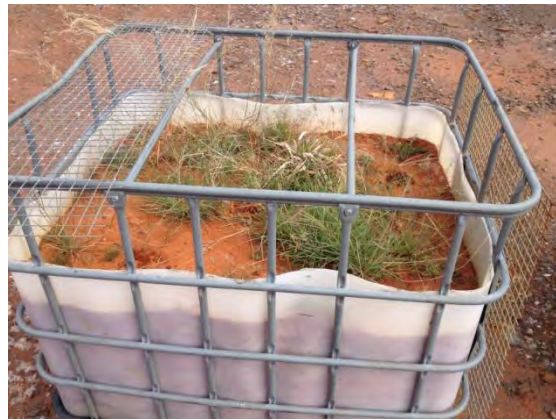
*As the majority of the site will remain active for the life of the mine, only limited progressive rehabilitation is possible. However extensive planning and trials into the rehabilitation of facilities such as the tailings dams are ongoing. A current ongoing trial located on Pit 8 at Sector 5 TSF (right) is measuring the impact on soils as a use in capping of tails. The trial measures:*

- *Matric suction;*
- *Soil temperature;*
- *Volumetric water content; and*
- *Electrical conductivity.*
